UNITED STATES ENVIRONMENTAL PROTECTION AGENCY

Subject: Removal Site Evaluation for the Barry Bronze Bearing Company Site, City of Camden,  
Camden County, New Jersey

Site I.D. No.: NJC200400018

### **Photo Documentation Barry Bronze Bearing Company Site**

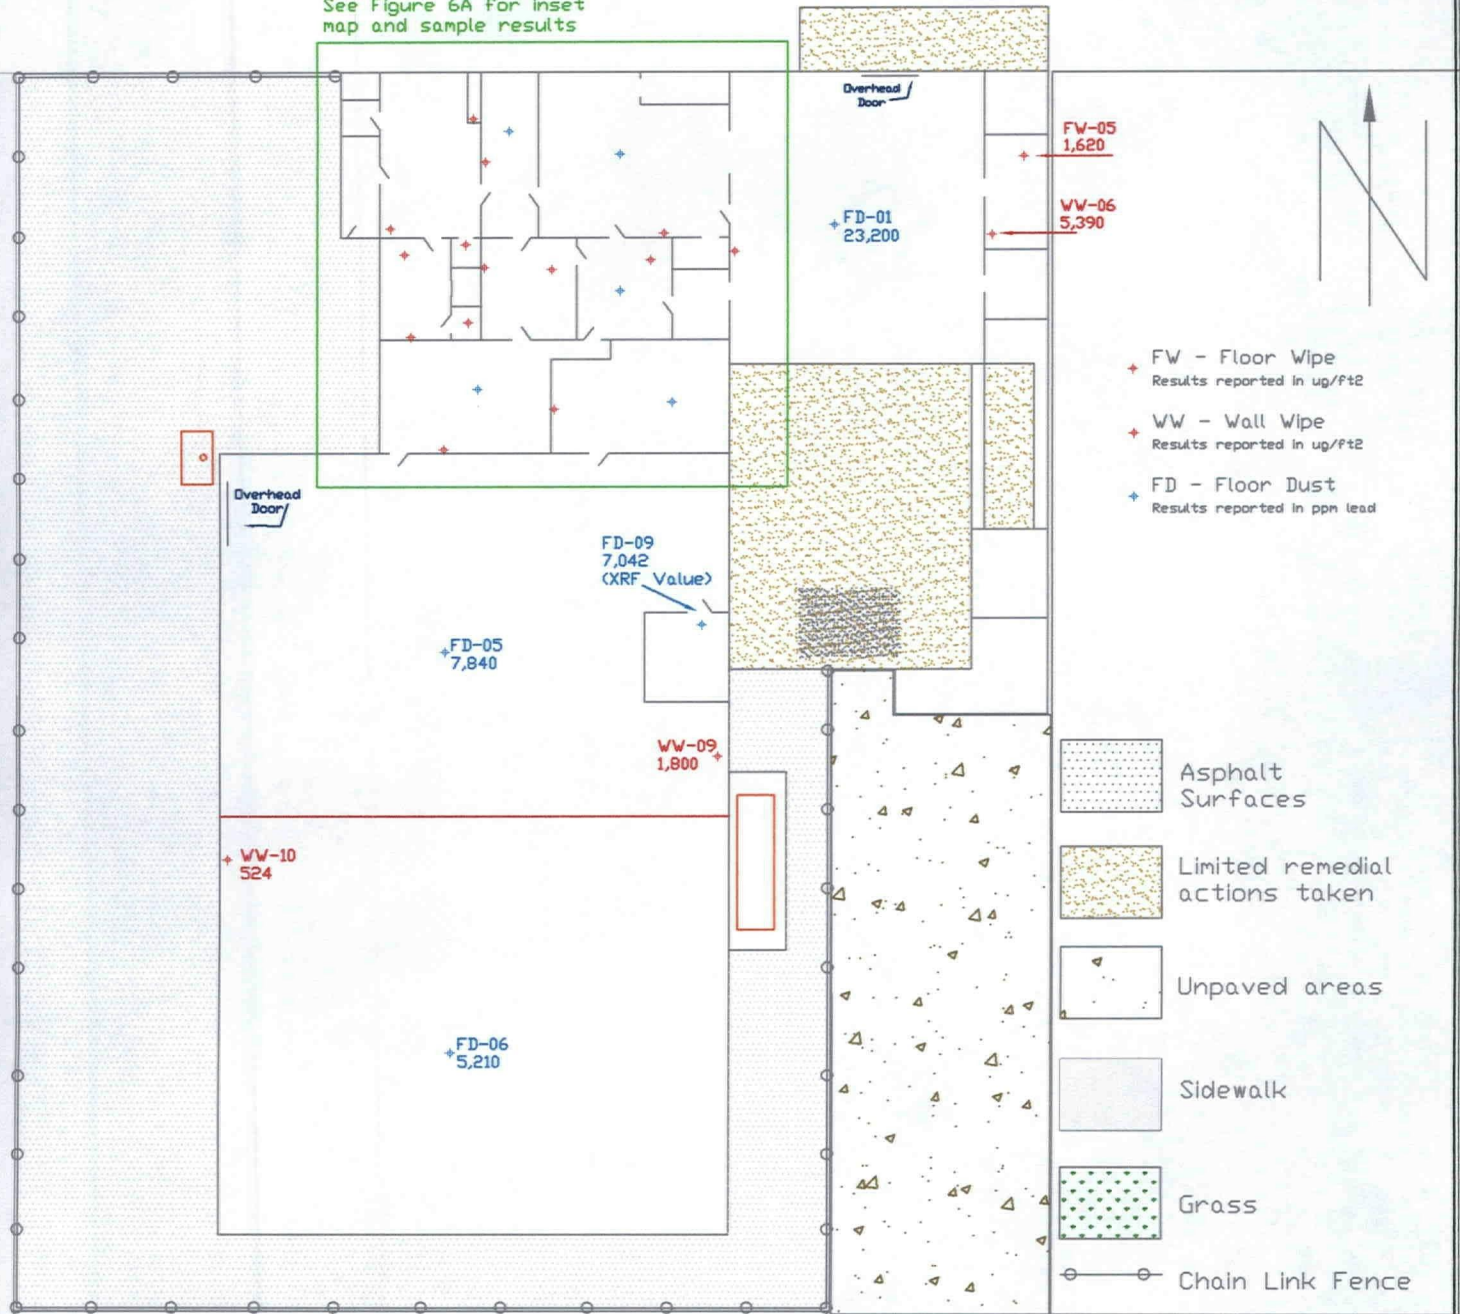
FIGURE 5  
INTERIOR SAMPLE LOCATION MAP WITH  
LABORATORY LEAD RESULTS (INSET)  
BARRY BRONZE BEARING CO. SITE  
2204 SOUTH SEVENTH ST  
CAMDEN, NEW JERSEY

Dust on the floors, walls and in the ventilation system within the building is grossly contaminated with lead (Table 1.2 and 3, Figures 5 through 8). Samples of building interior dust showed lead up to 23,200 ppm. Wipe samples from the walls showed lead concentrations of up to 54,800 ug/ft<sup>2</sup>. Samples of sand in the foundry room showed lead concentrations up to 17,500 ppm. The persons currently accessing the building are being exposed to the contaminated dust and are also providing a potential avenue for additional lead contamination to migrate from the building to areas off of the Site. Future releases to the outside environment will continue on the clothing and shoes of anyone who enters the building.

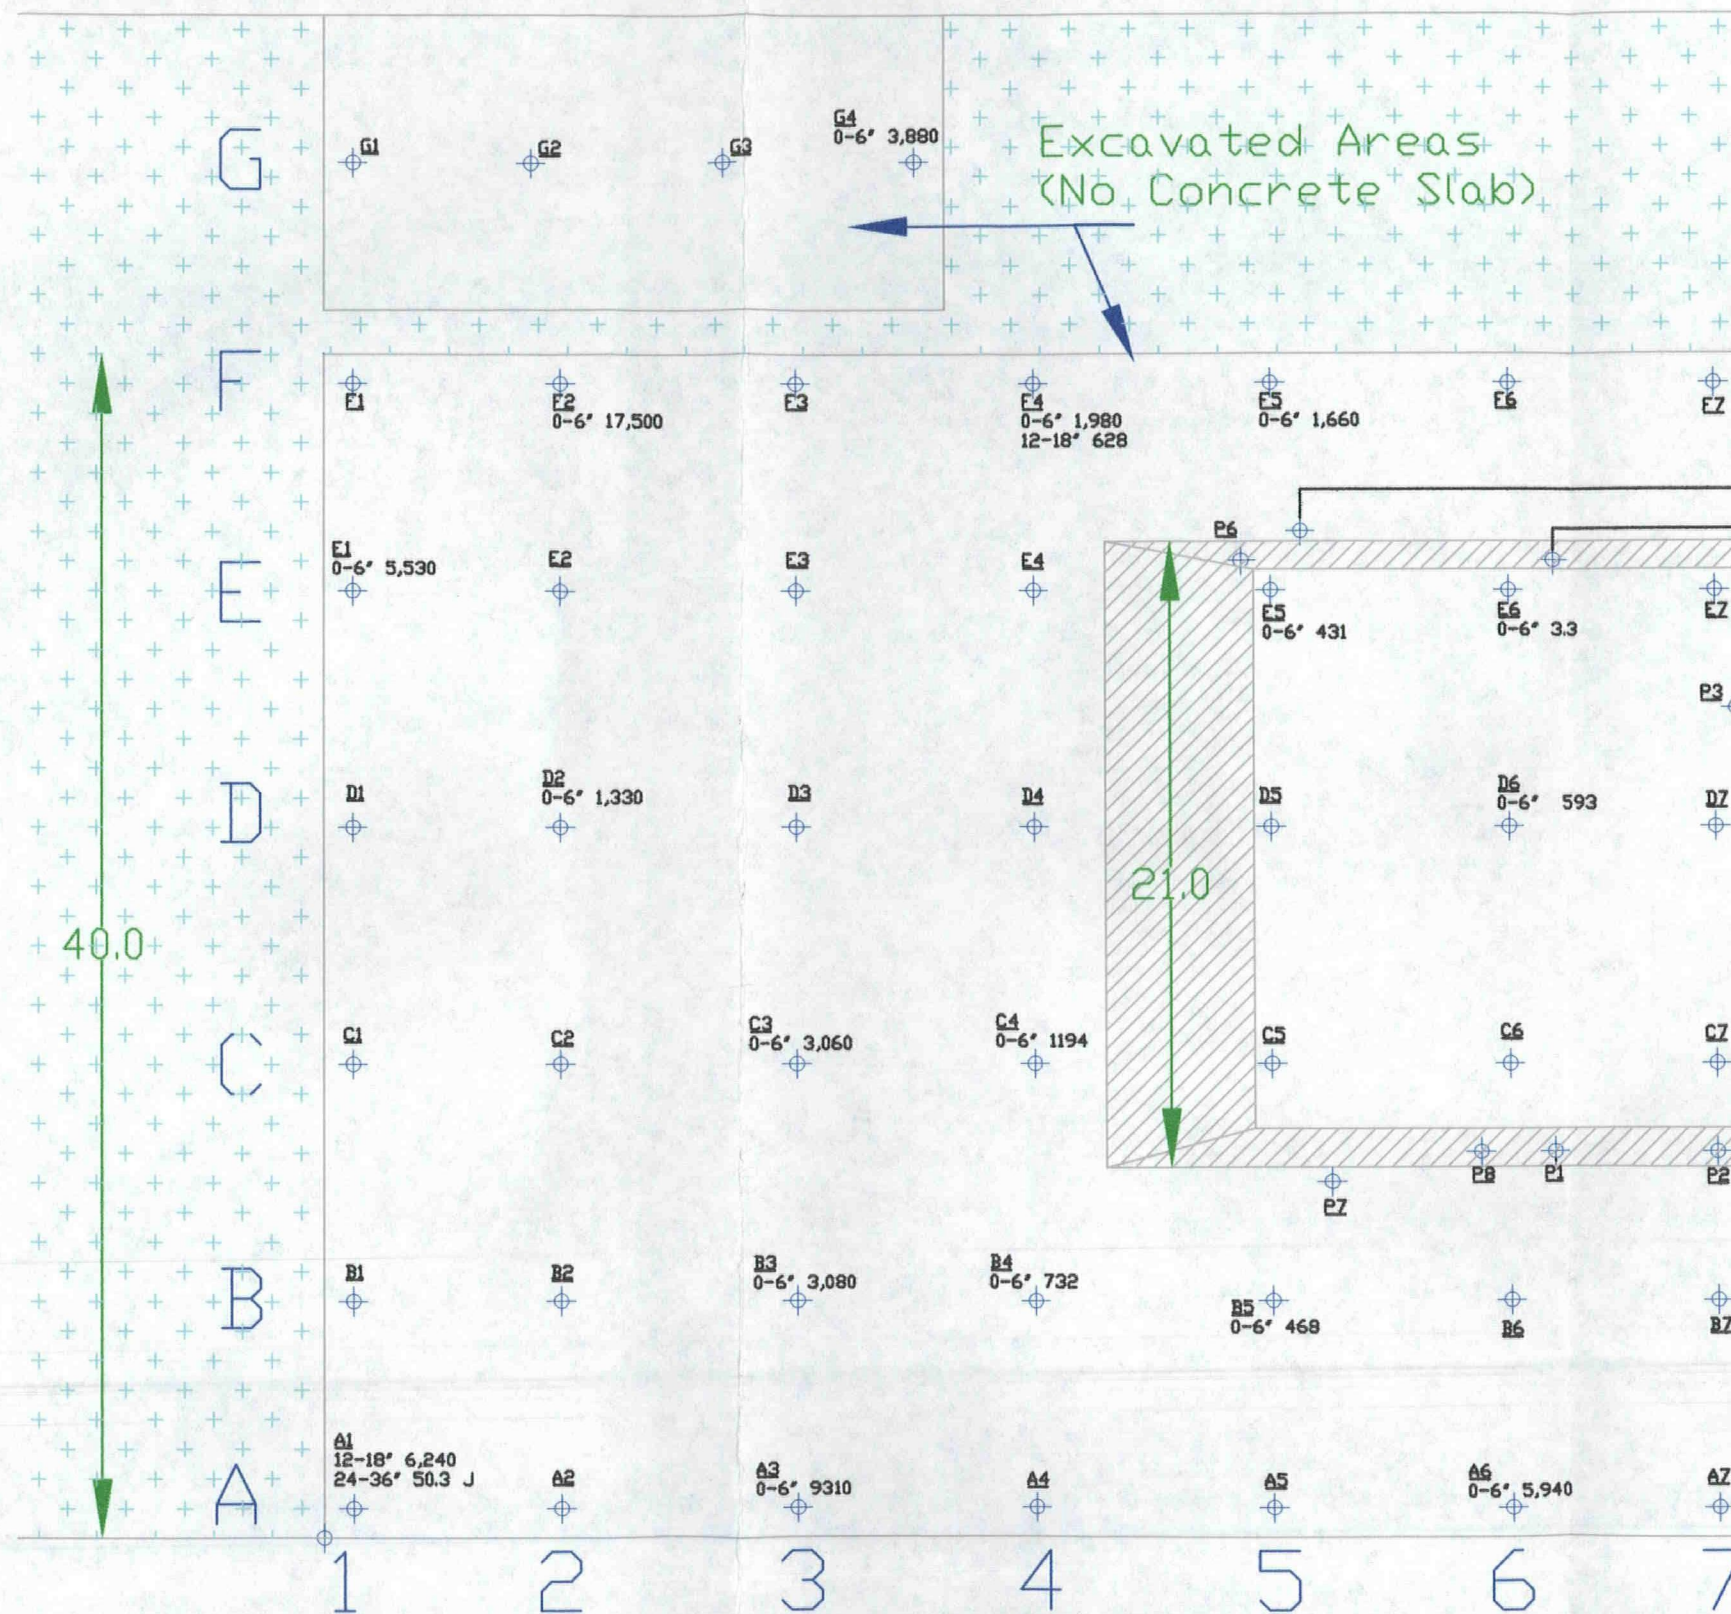
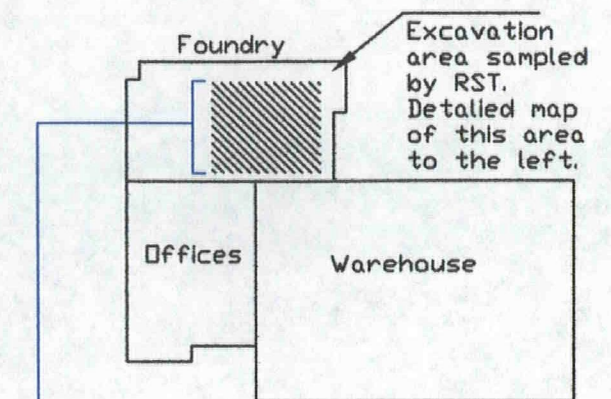
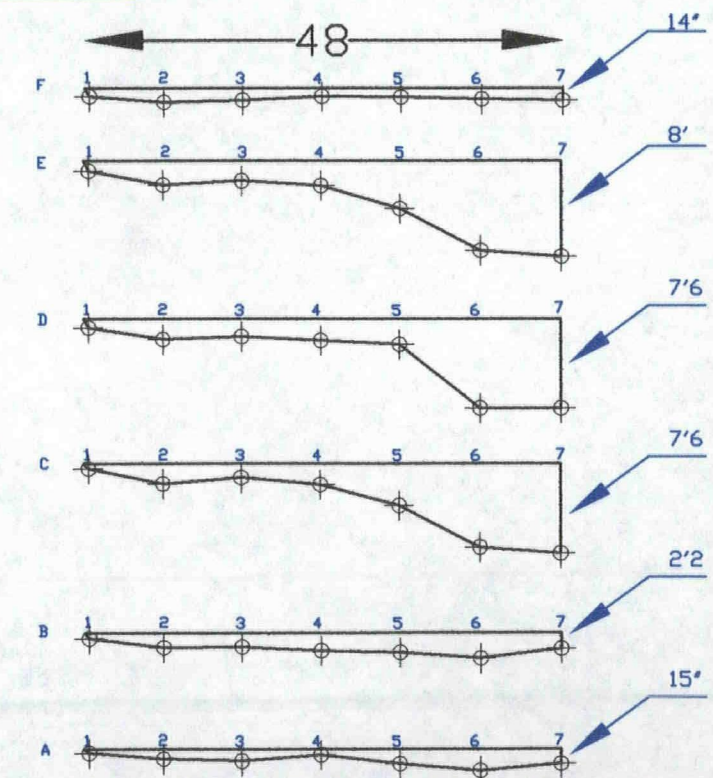
Figure 8  
FOUNDRY SAMPLE LOCATION  
MAP WITH LABORATORY RESULTS  
BARRY BRONZE BEARING CO. SITE  
CAMDEN, NEW JERSEY

Depth profiles along the sample grid lines A-F. Maximum depths from the foundry concrete floor shown on the right.

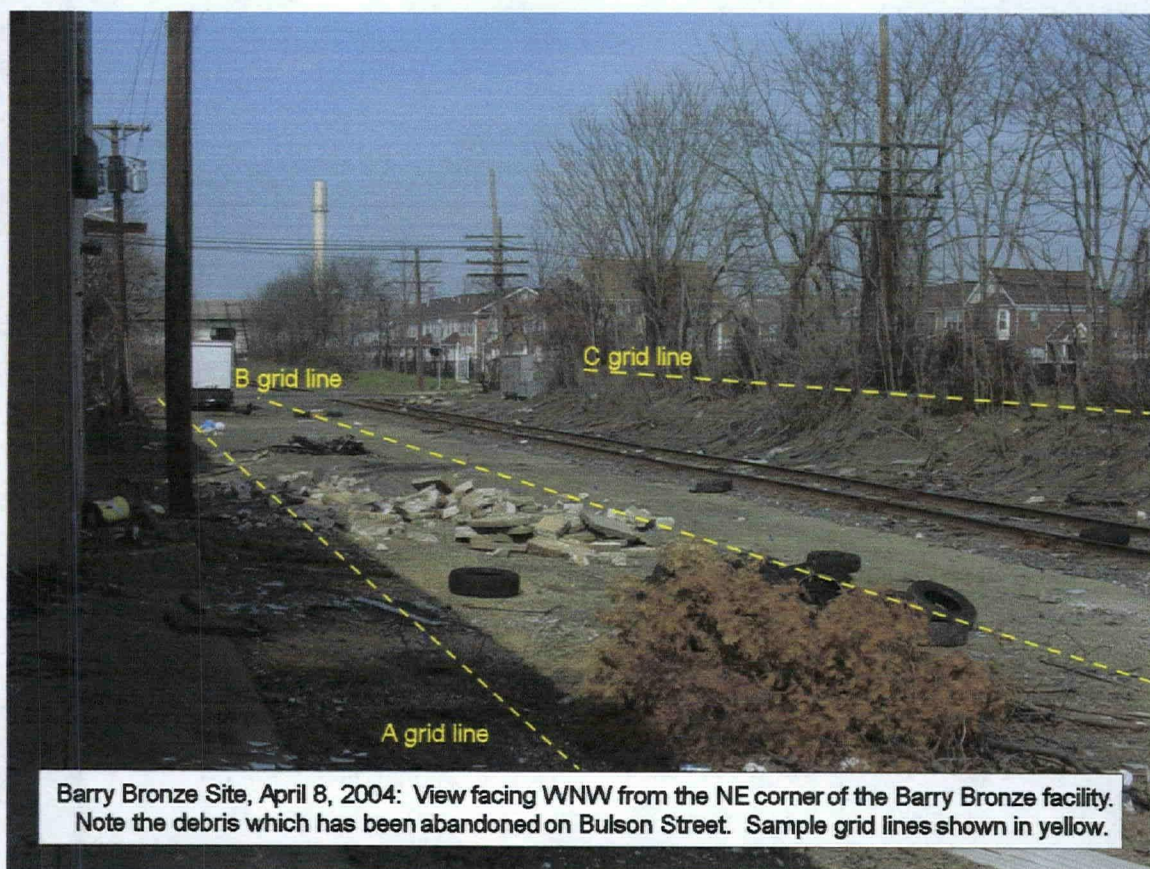
Barry Bronze Site, April 8, 2004: View facing WNW from the NE corner of the Barry Bronze facility. Note the debris which has been abandoned on Bulson Street. Sample grid lines shown in yellow.

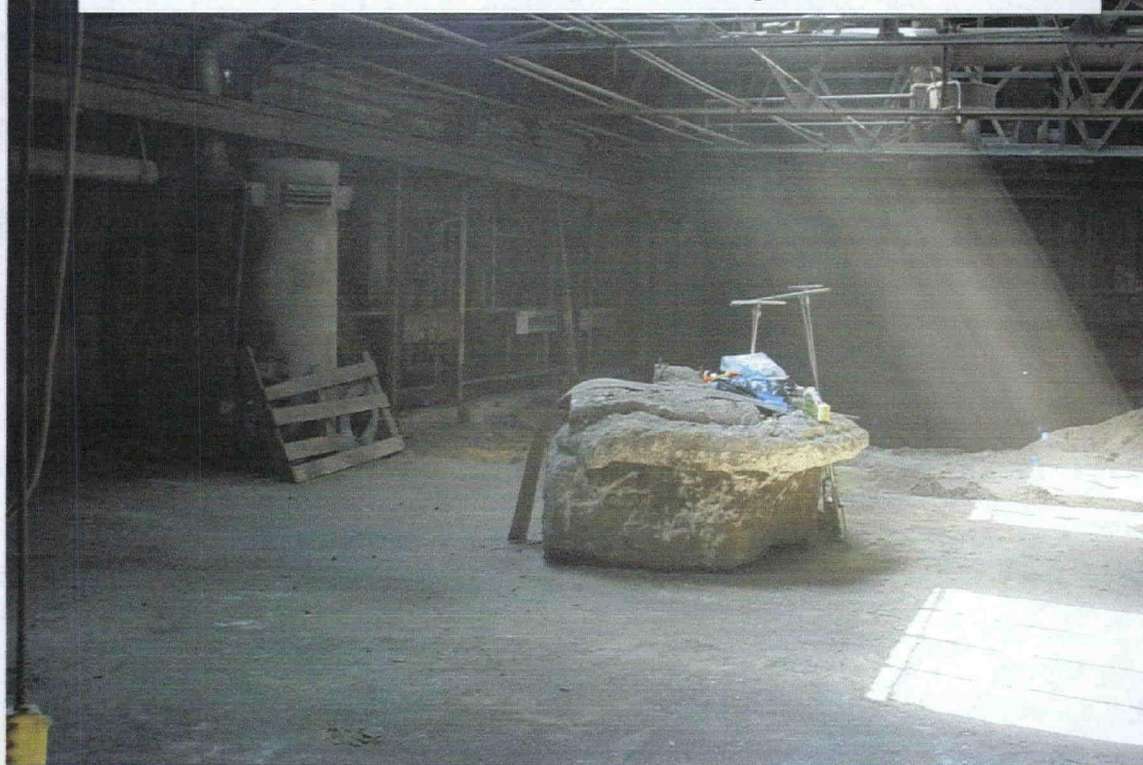
**Barry Bronze Bearing Site, May 6, 2004: View facing south of the foundry. Note the heavy dust in the air due to work being conducted in the area.**

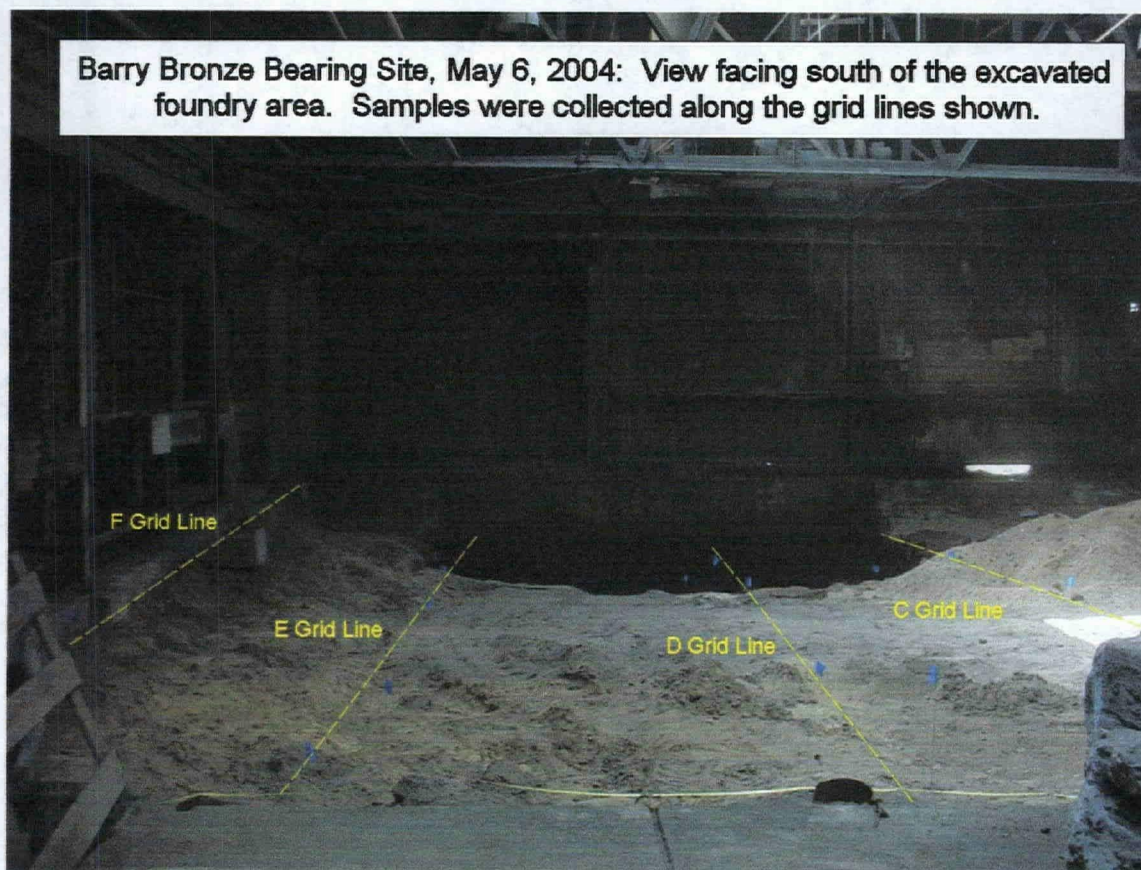
**Barry Bronze Bearing Site, May 6, 2004: View facing south of the excavated foundry area. Samples were collected along the grid lines shown.**

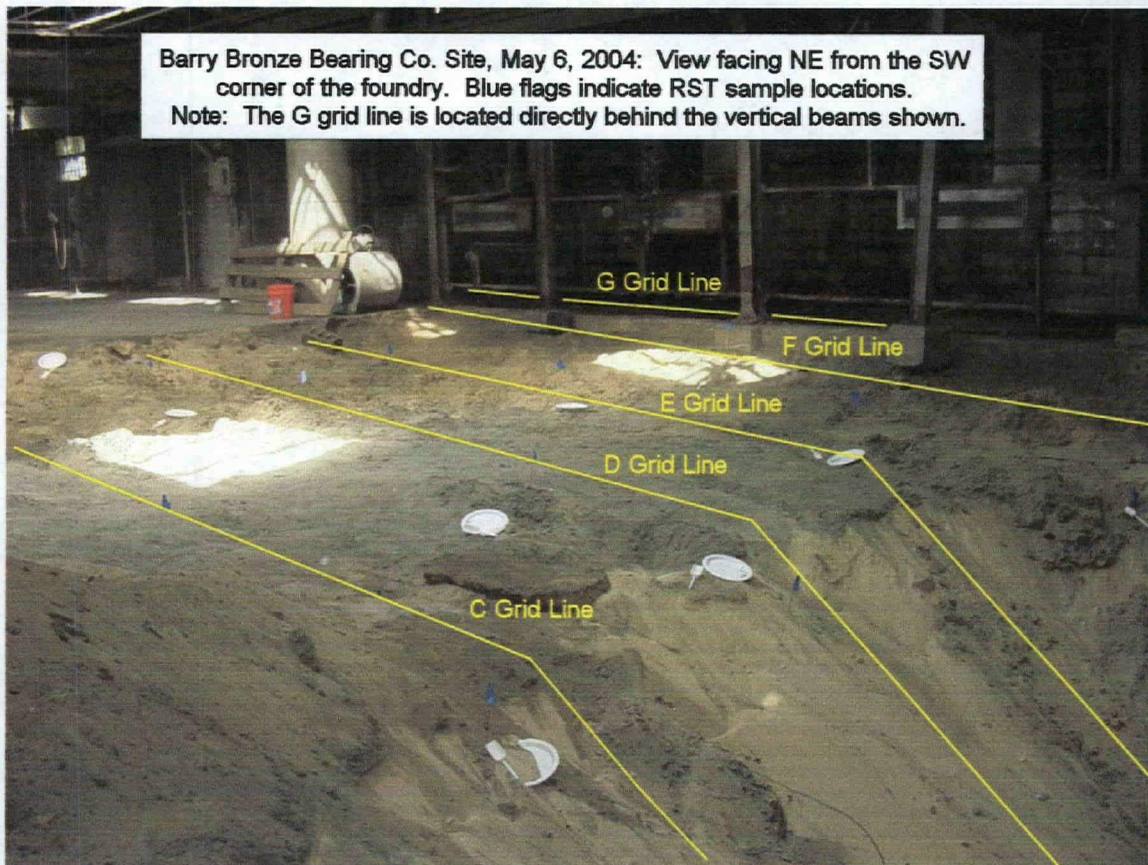
Barry Bronze Bearing Co. Site, May 6, 2004: View facing NE from the SW corner of the foundry. Blue flags indicate RST sample locations.  
Note: The G grid line is located directly behind the vertical beams shown.

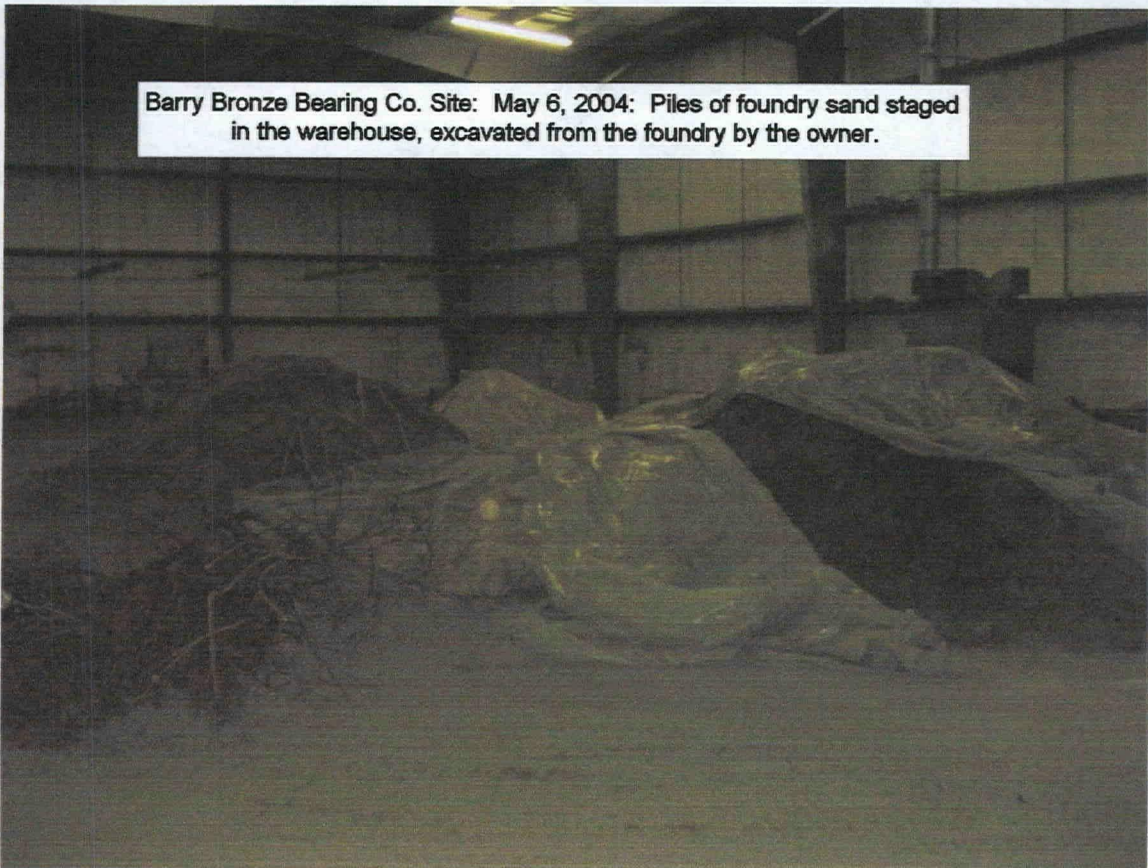
Barry Bronze Bearing Co. Site: May 6, 2004: Piles of foundry sand staged in the warehouse, excavated from the foundry by the owner.

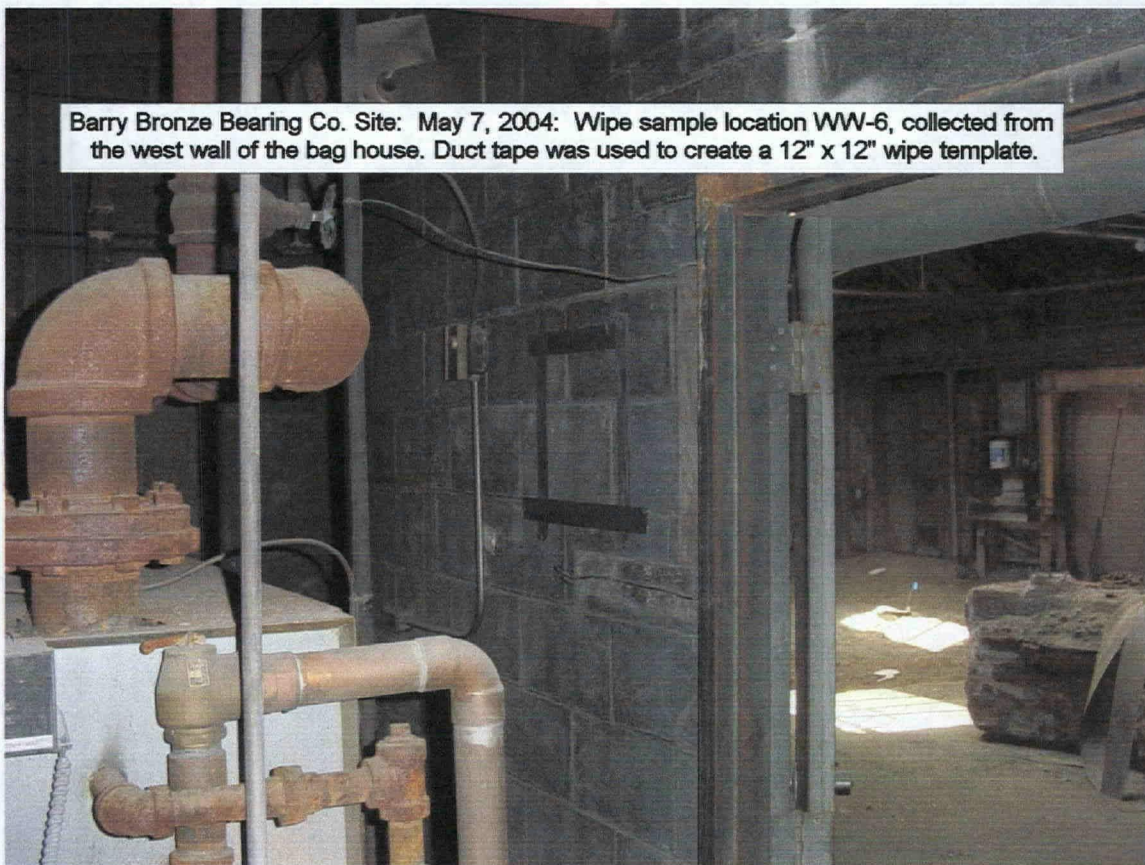
Barry Bronze Bearing Co. Site: May 7, 2004: Wipe sample location WW-6, collected from the west wall of the bag house. Duct tape was used to create a 12" x 12" wipe template.

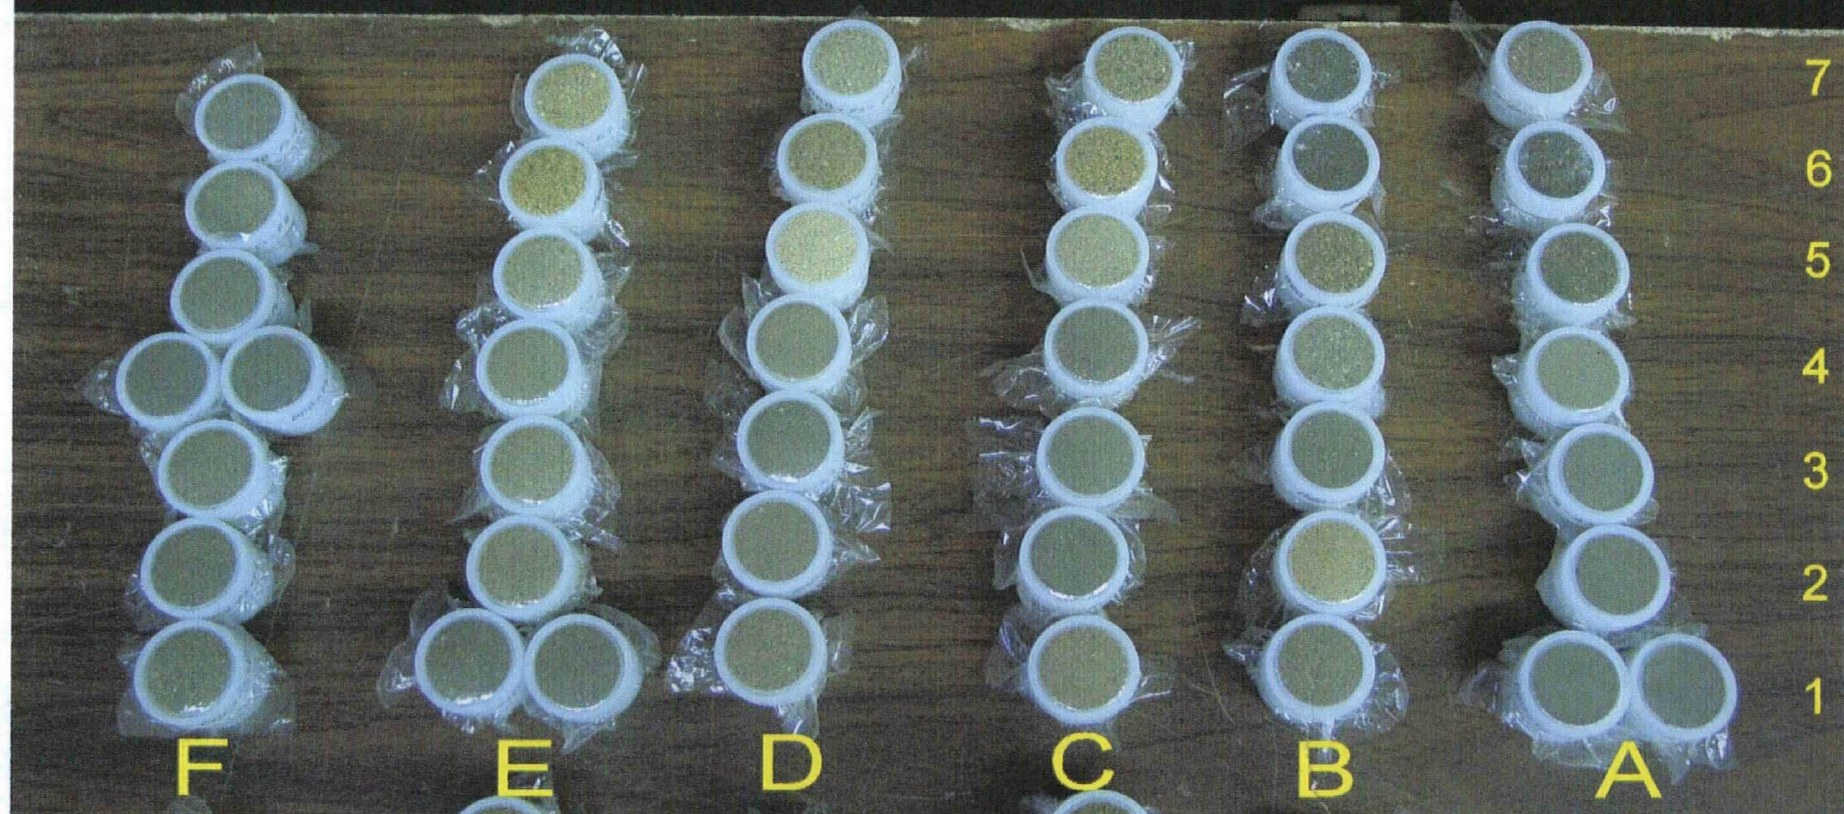
Barry Bronze Bearing Co. Site: May 7, 2004: View of XRF sample cups as they were collected from the foundry surface. Note the color change in the C,D,E 5-7 cups. These samples were collected in the furnace pit and yielded significantly lower lead concentrations than the surrounding darker sand.
